APPLICATION FOR HISTORIC LANDMARK DESIGNATION

Historic Name: Frank H. and Rose Budd Chamberlain House

Street Address: 415 E. Sumner Street, Lincolnton, NC 28092

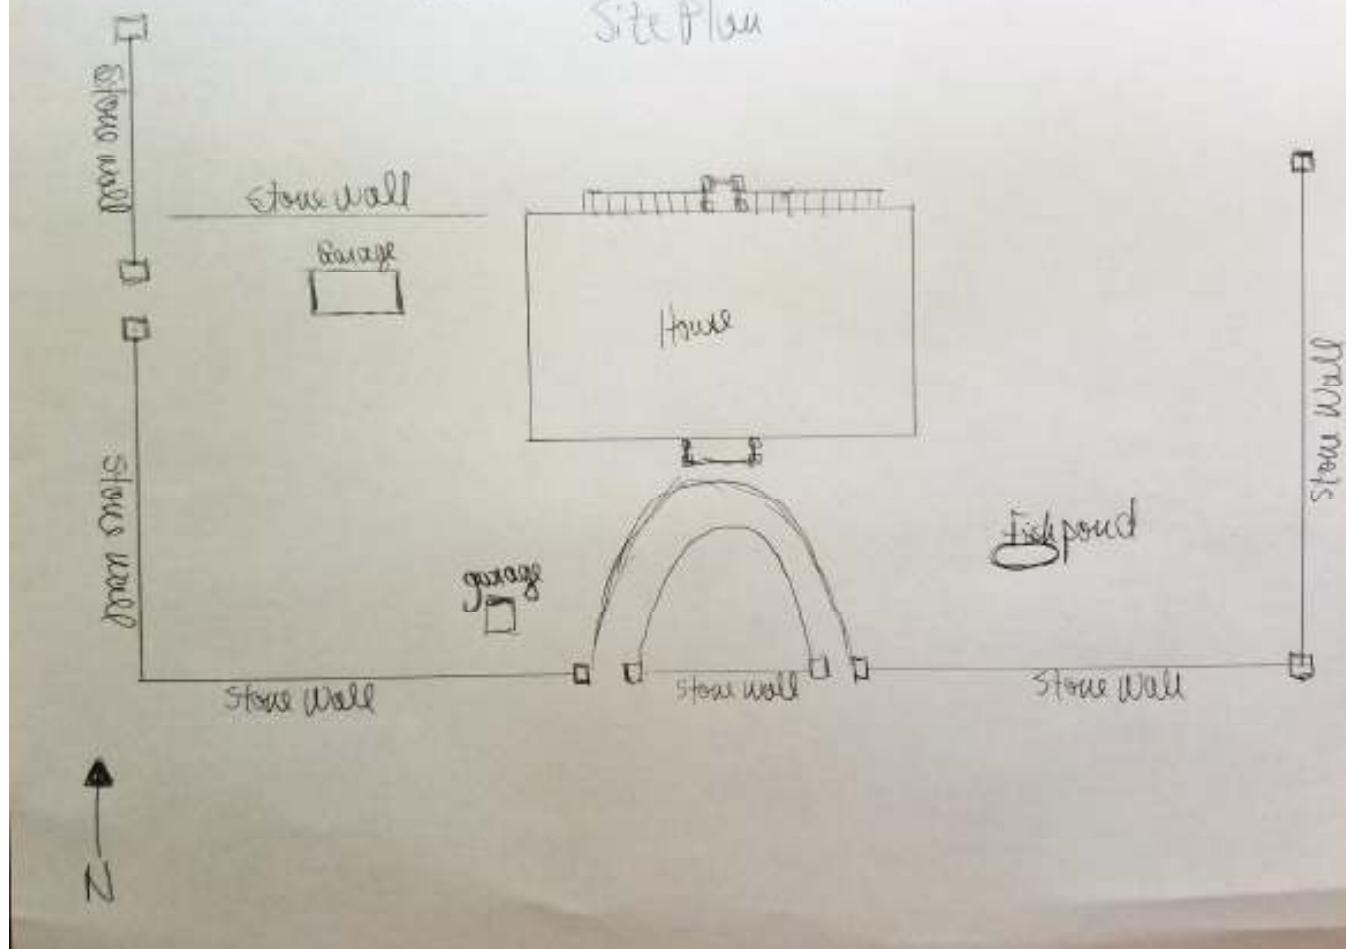
Frank H. + Rose Budd Champlain Farm, Lincolnton, Lincoln Co., NC
Site Plan

The Frank H. and Rose Budd Chamberlain House, built ca. 1927, and located at 415 E. Sumner Street in Lincolnton, Lincoln County, North Carolina, occupies an entire 3.59 acre block. The house and property are located four blocks from East Main Street in downtown Lincolnton, and the large square parcel includes the two-story Colonial Revival House, a ca. 1927 garage, and a 1980s garage. Rose Budd Chamberlain designed the house, the property's hardscape features, and likely designed the ca. 1927 garage.²⁵ The property is one of the largest in downtown Lincolnton, and is surrounded by stone walls at its eastern, western, and southern boundaries. The property contains a number of hardscape features such as a low, rough stone-lined former driveway, low stone-lined walls, stone steps, and a stone fishpond. Access to the house is afforded at the property's southern, eastern, and western boundaries by a circle driveway that was paved in the late 1980s, a former driveway, and a driveway leading to the 1980s garage, respectively.

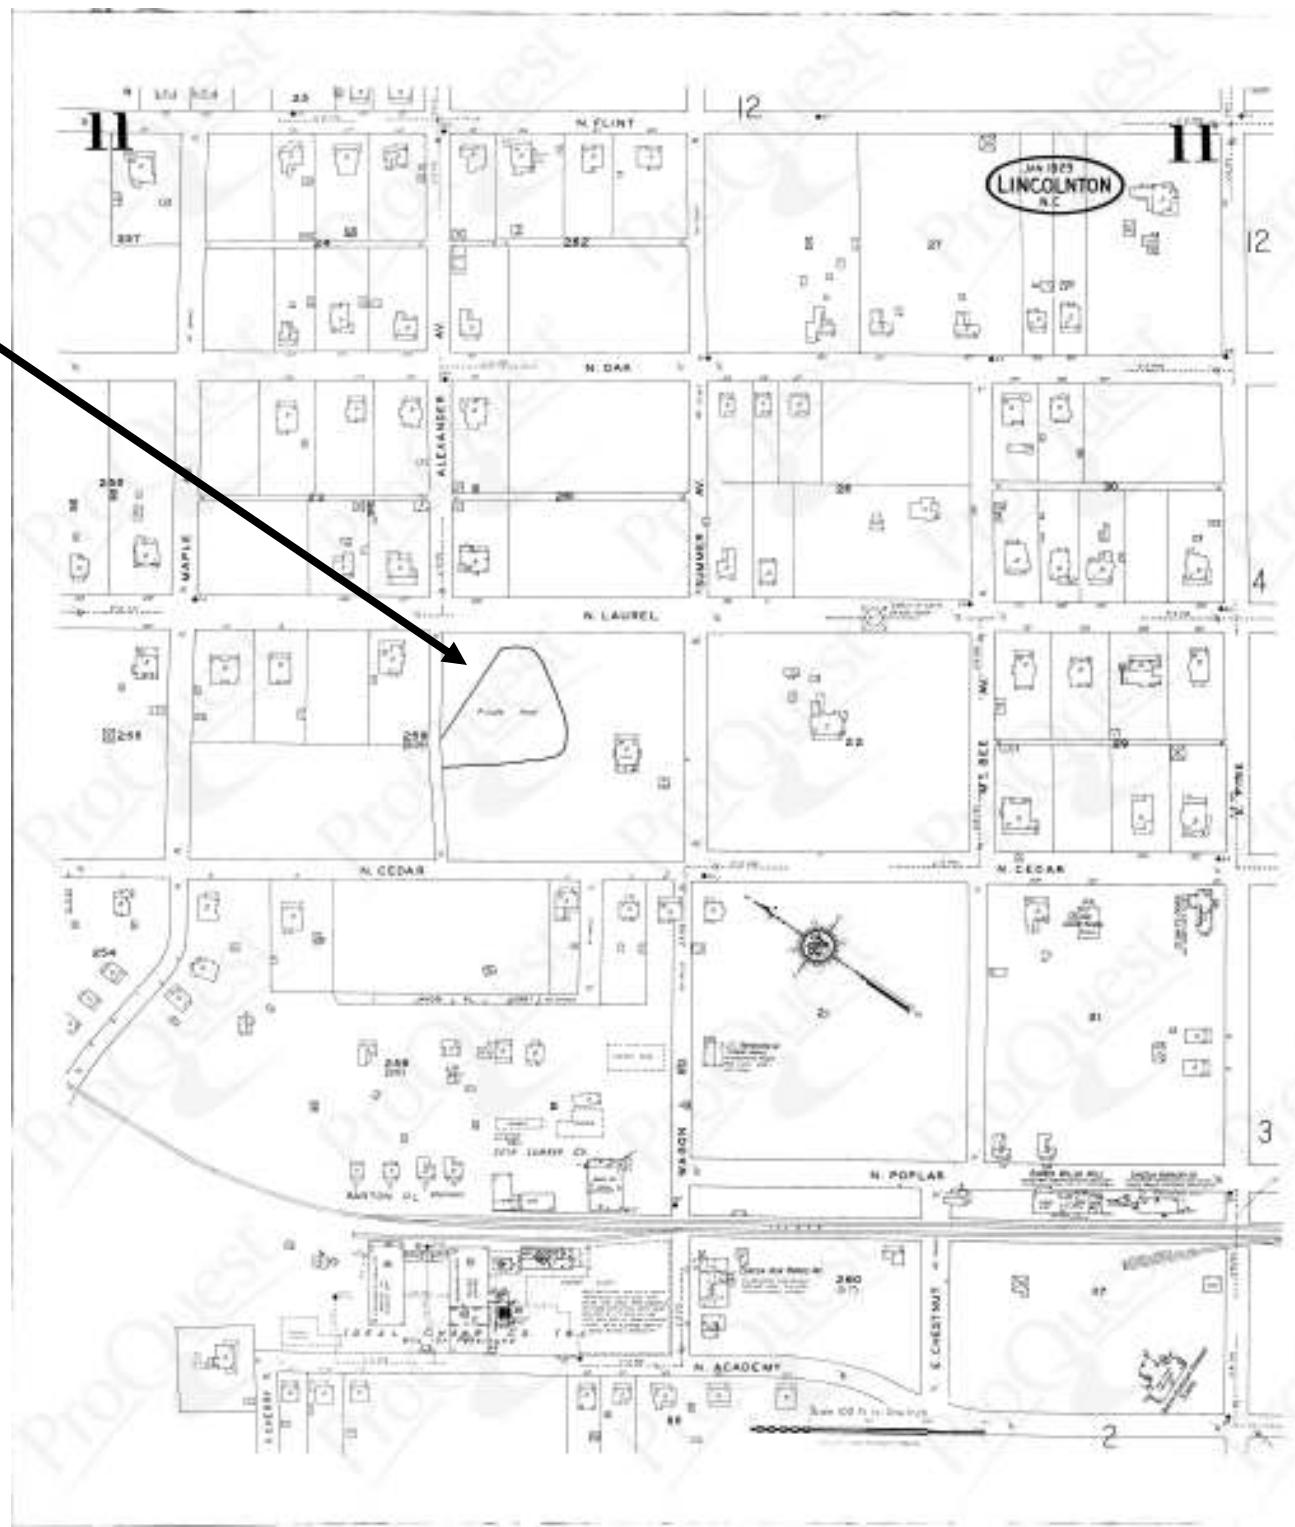
Sanborn Map, Lincolnton, NC 1929

The property is bounded on the north by a heavily-wooded area of large hardwoods and thick underbrush that was once a large pond (see 1927 Sanborn map), on the east by North Laurel Street, on the south by E. Sumner Street, and on the west by North Cedar Street. The house stands at the southern end of the property, and is visible from the east, west, and south elevations. The property slopes slightly from E. Sumner Street to the house and then has a more drastic slope from the house to the heavily wooded northern boundary. Pairs of tall, square stone piers flank each end of the concrete-paved, semi-circular driveway that empties onto E. Sumner Street. The driveway leads to the front of the house and is lined by boxwoods, ivy, and small shrubs, as well as low-lying stonework that terminates at the stone piers.

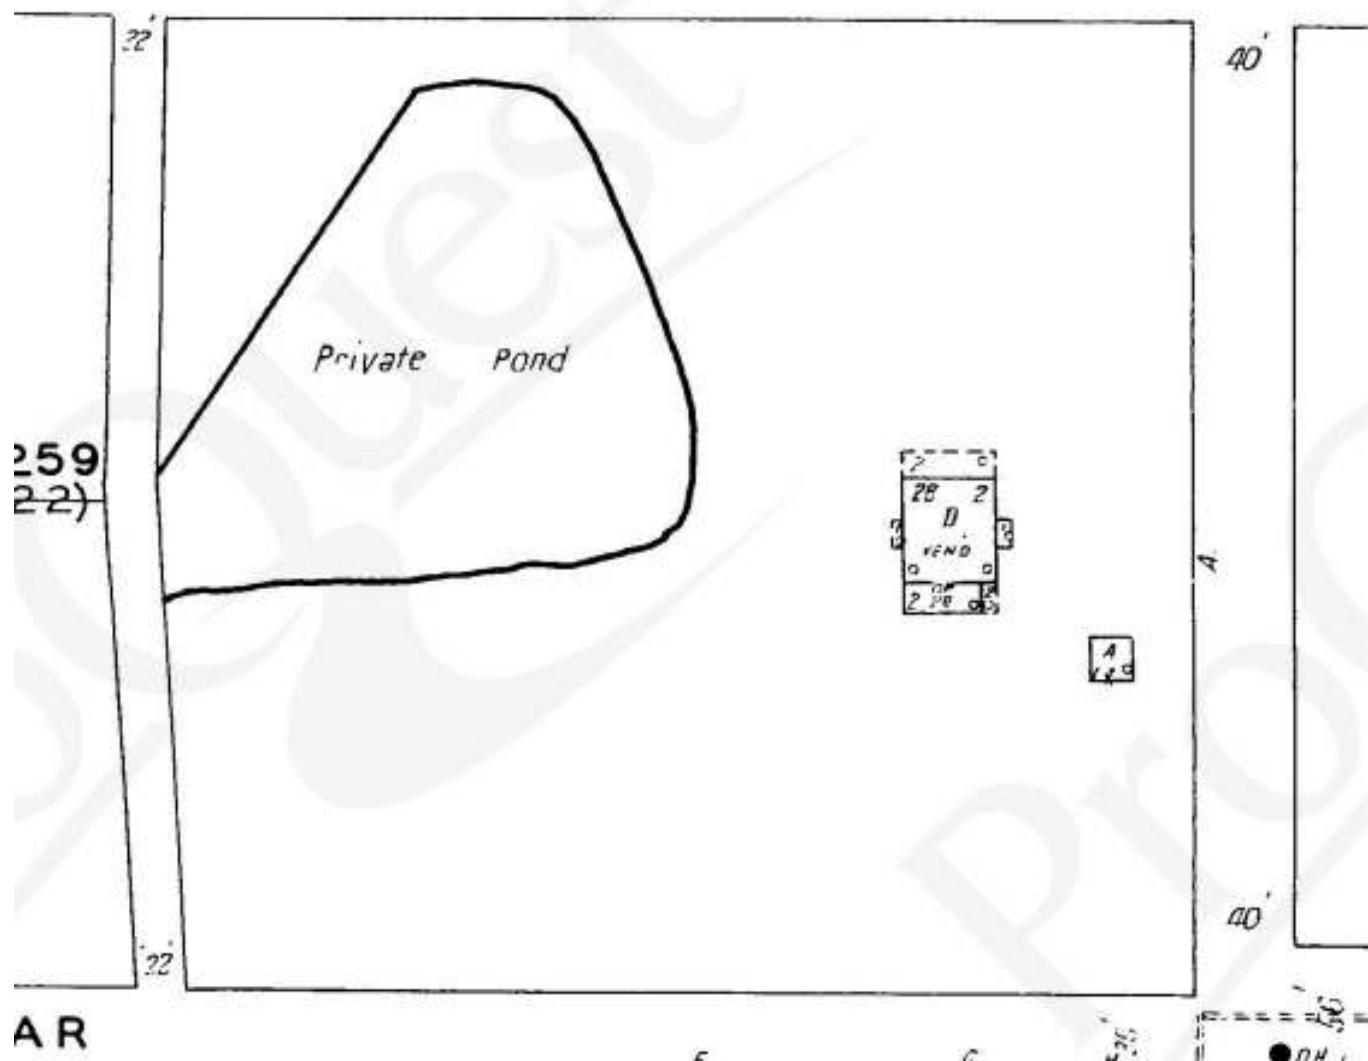
Sanborn Map, Lincolnton, NC 1929
